Steel Chemistry

Microstructure of Hull Steel

Rivets

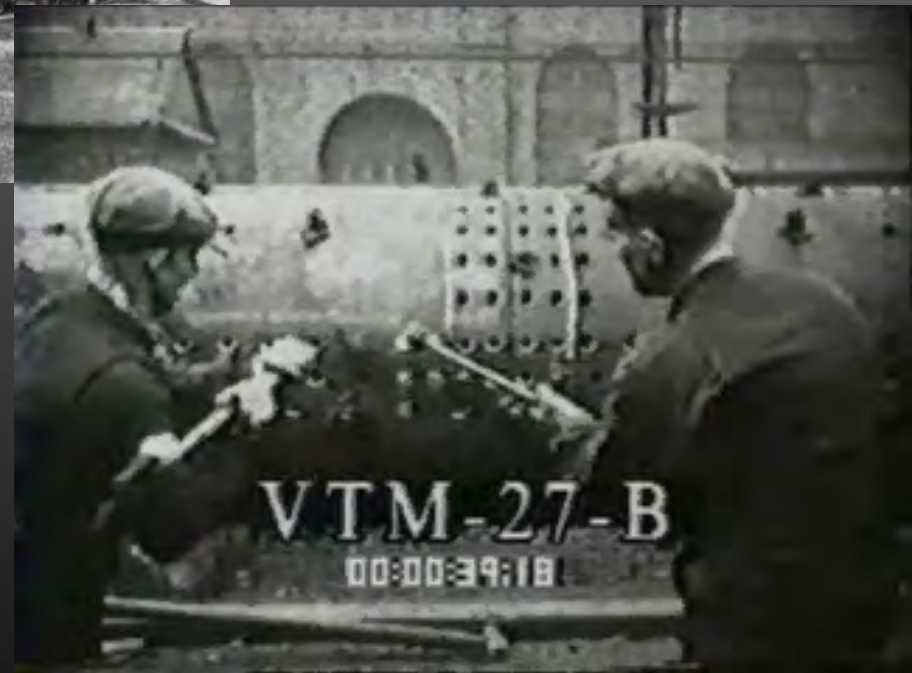
Riveting

- 3,000,000 wrought iron and steel rivets
- Hand and hydraulically driven
- Total weight = 1,550 tons

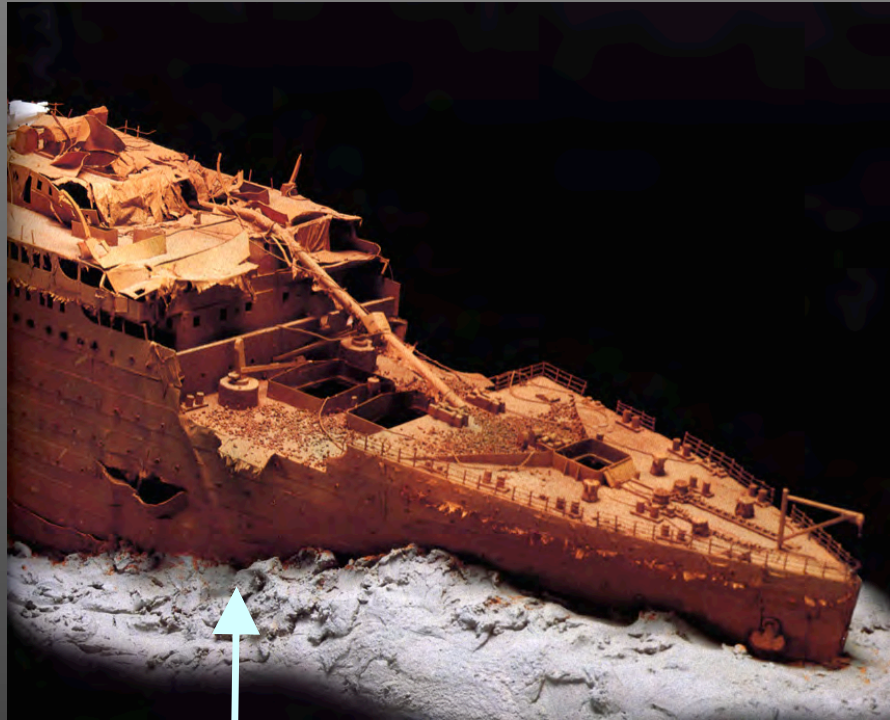
New images of parted seams in damage area

- Located by counting plates
- Right where Fireman Barrett said it was

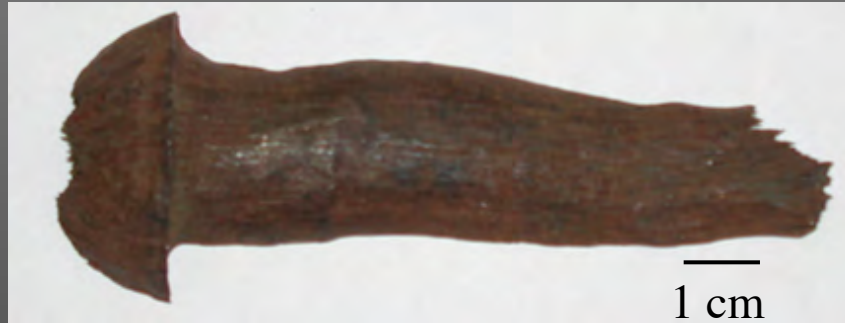
- Mid-shaft failure

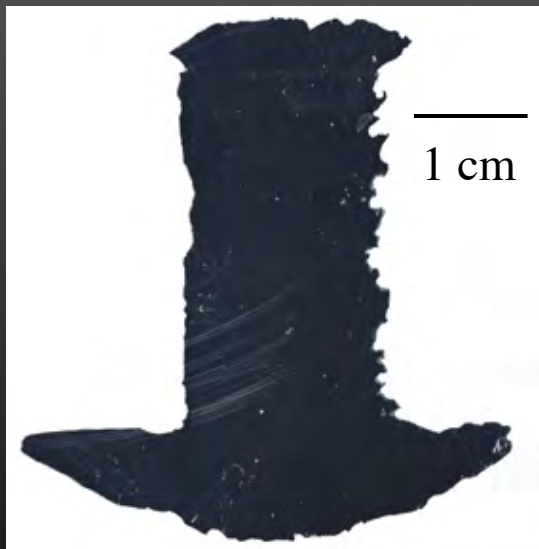
- Head “pops” off

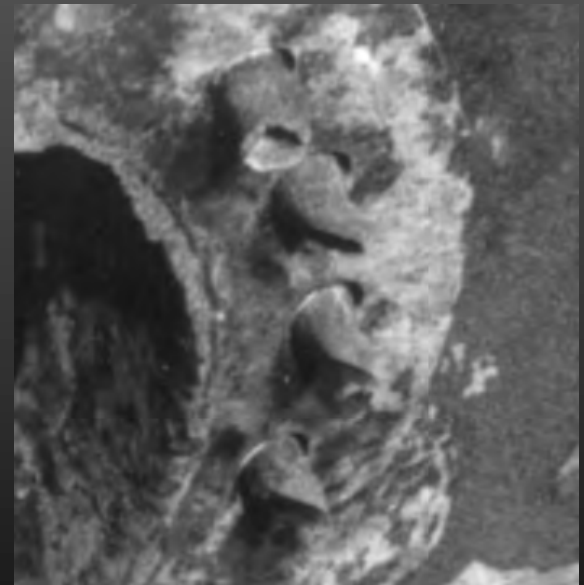
- Cupping
