Hypothesis:

Did the re-orientation of large slag stringers in the wrought iron rivets in the impact zone cause the rivet heads to fail prematurely?

Microstructural Analysis

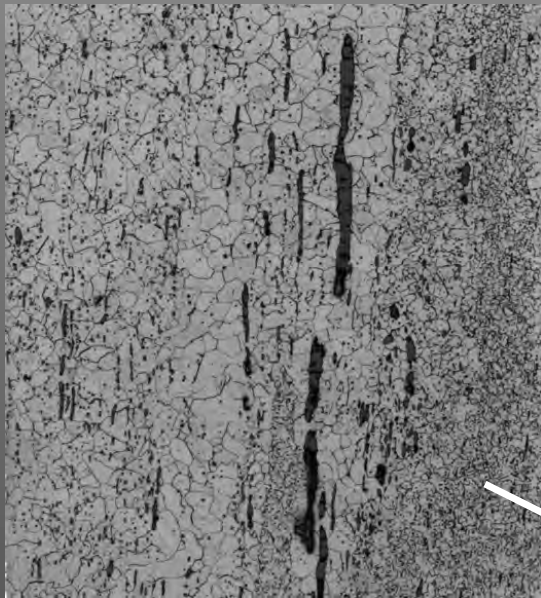
Slag stringers parallel to rivet shaft

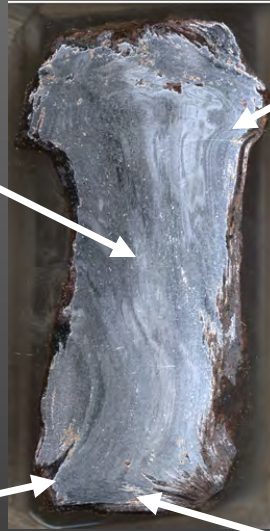
Slag stringers perpendicular to rivet shaft

Missing a head

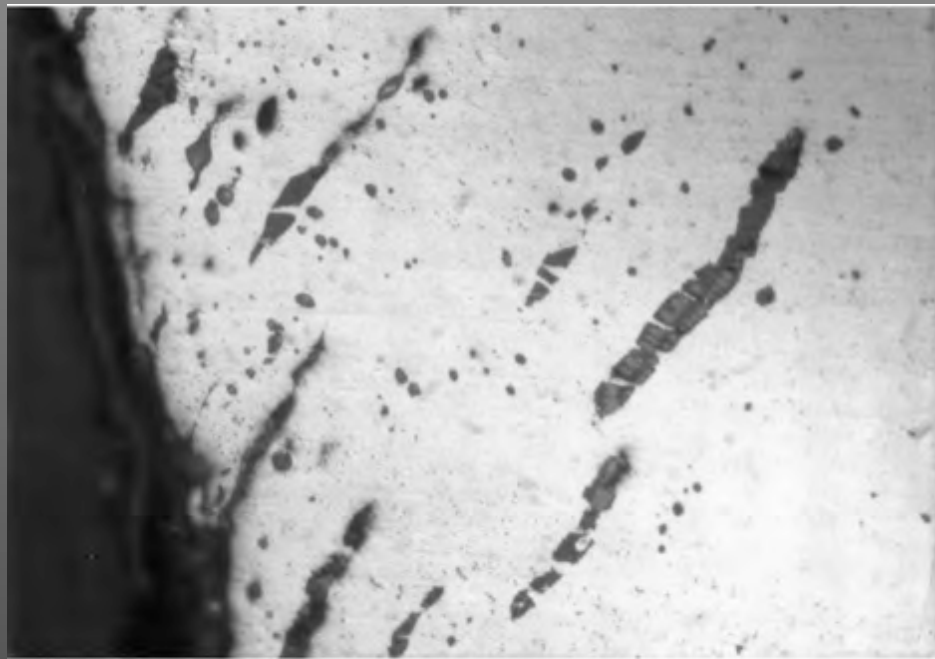
Farmers Bank Building (1903)
Pittsburgh, PA

12 rivet average: 1.9% slag

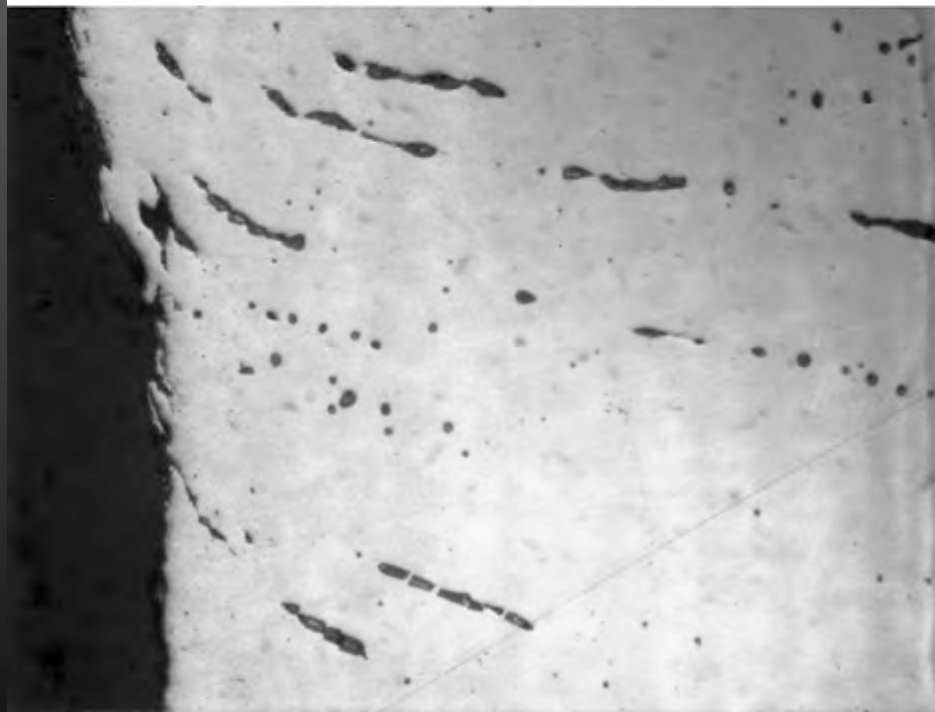
RMS Titanic (1911)

48 rivet range: 2 - 17% slag

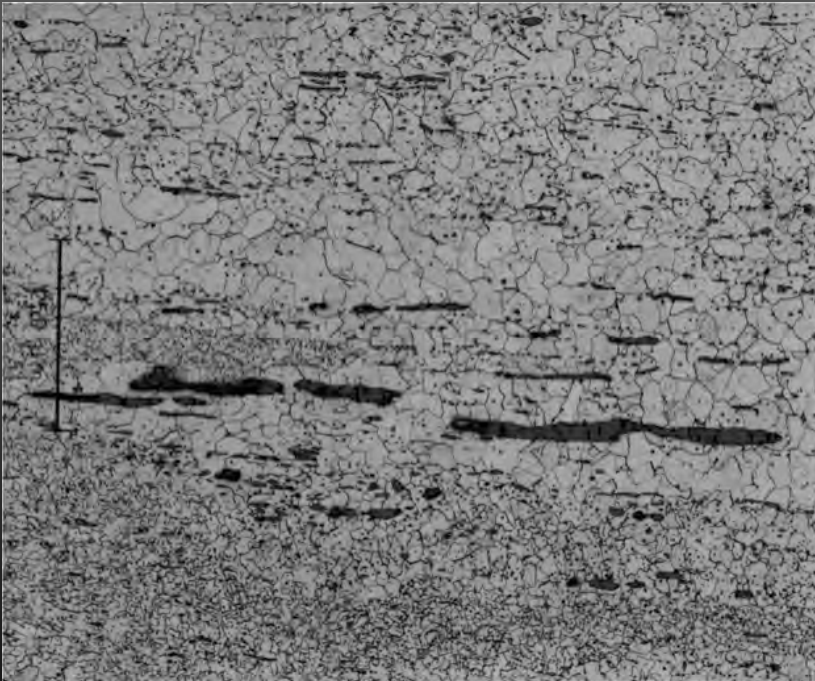
Wrought Iron Rivets

- Commercially pure iron with 1-4% incorporated slag (iron silicate)
- Puddled, extruded into a bar, and formed into rivets

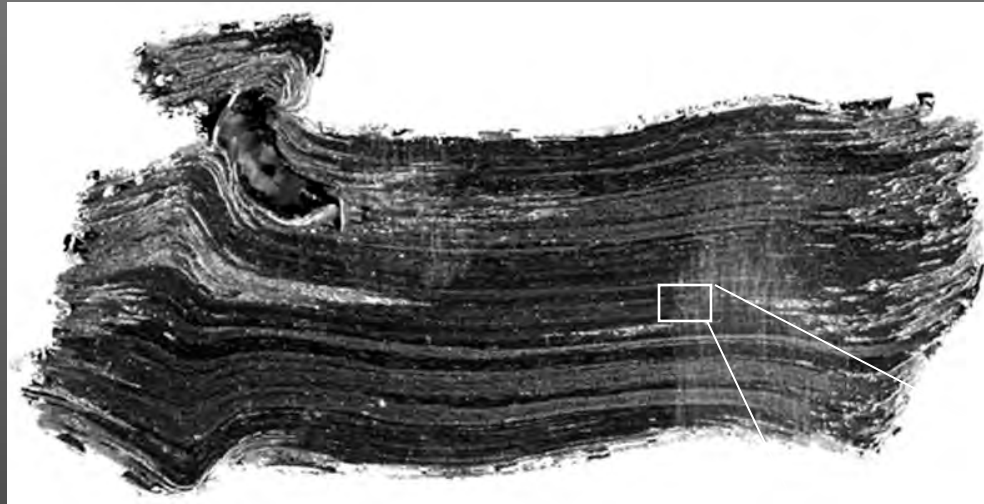
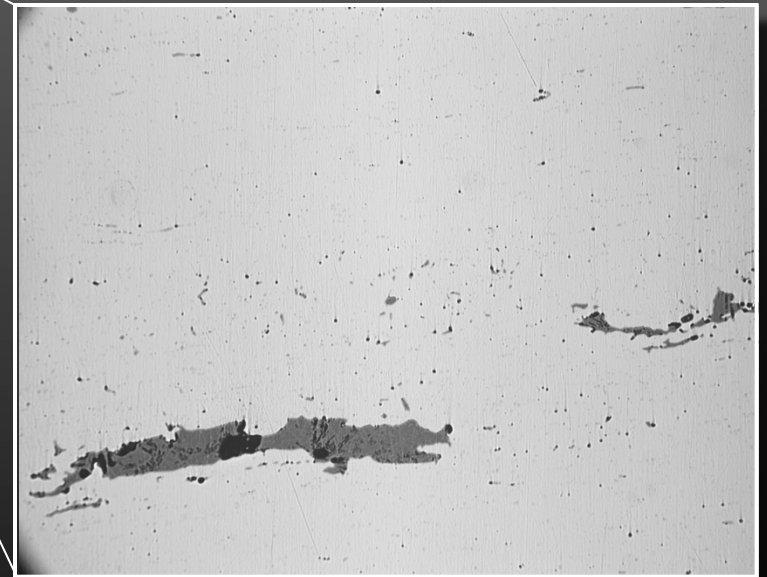
Polished cross-sections were digitally imaged at 100X to create a mosaic of each rivet's surface (100-1200 per rivet).

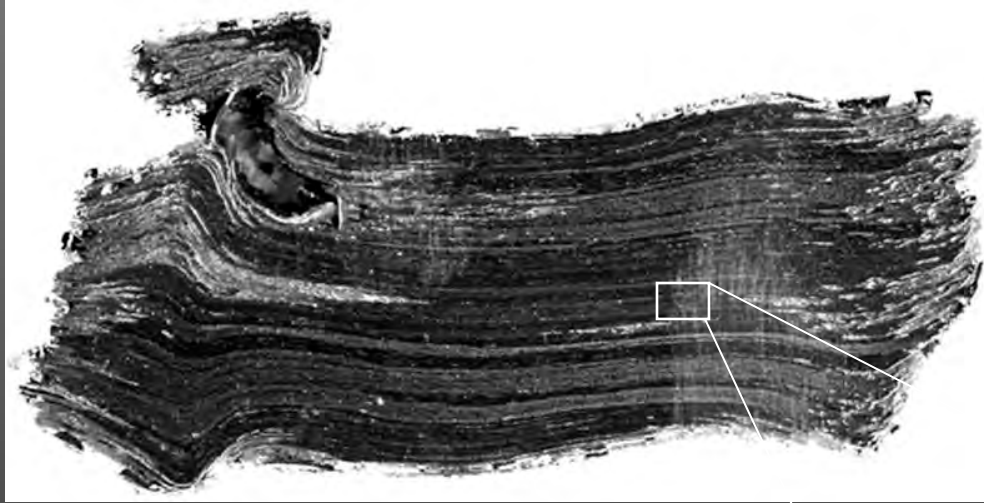
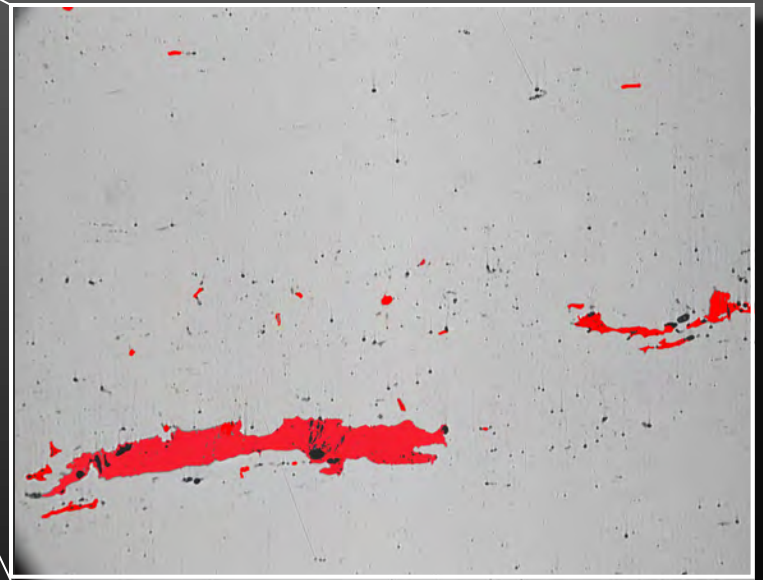
Measurements include:
Slag area percent, aspect
ratio, orientation and
particle size

Images were analyzed using
software that selects slag
regions using an automated
sequence based on greyscale
values.

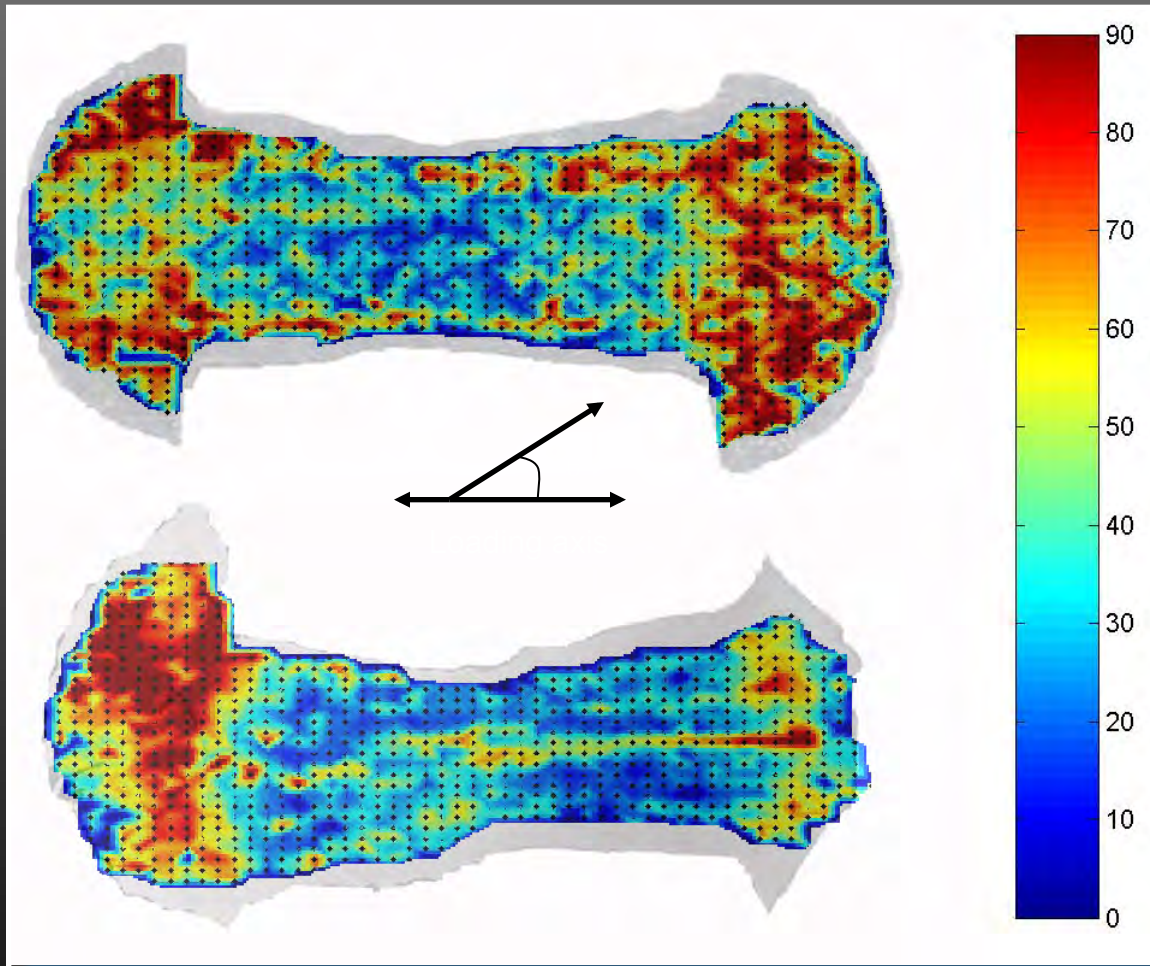
Titanic Hull Rivets

Orientation

Degrees (θ)

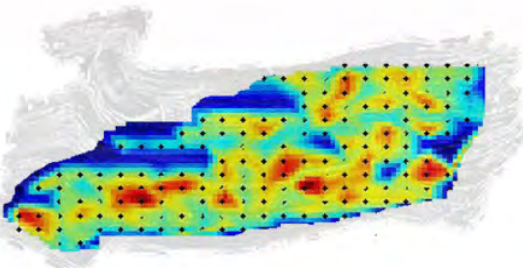
Bulkhead rivet

Area Percent of Particles

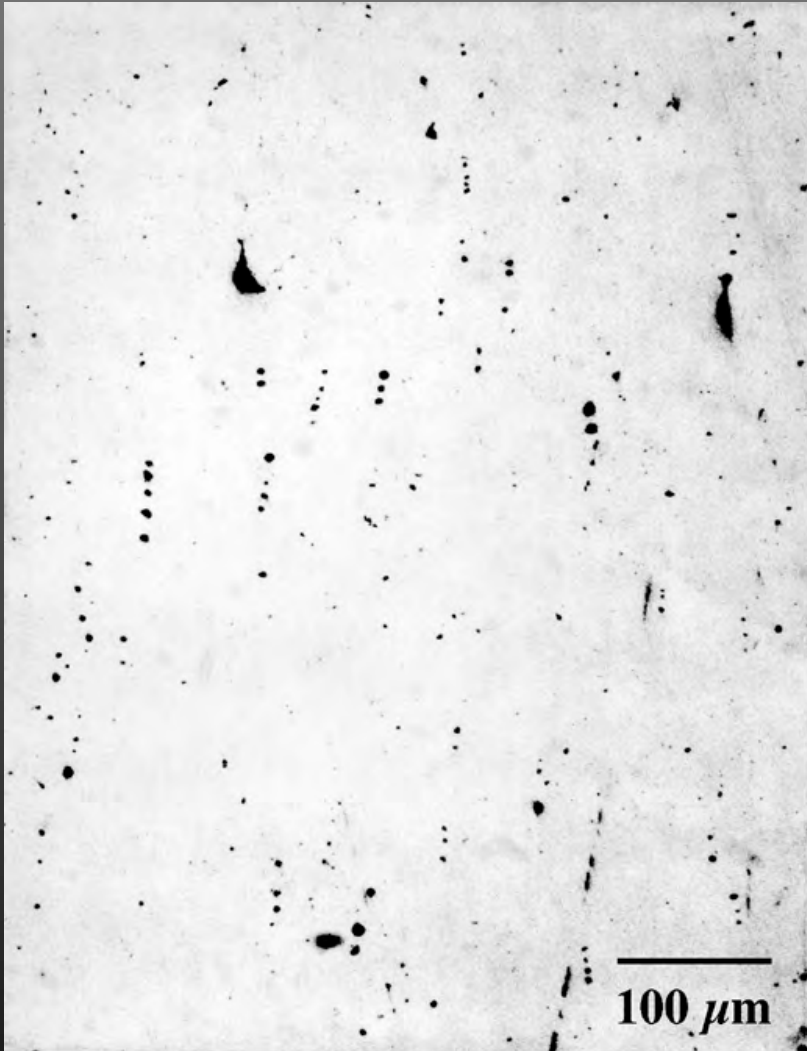
Good Titanic Hull Rivet

- 1.9% slag
- fine fibers
- well distributed

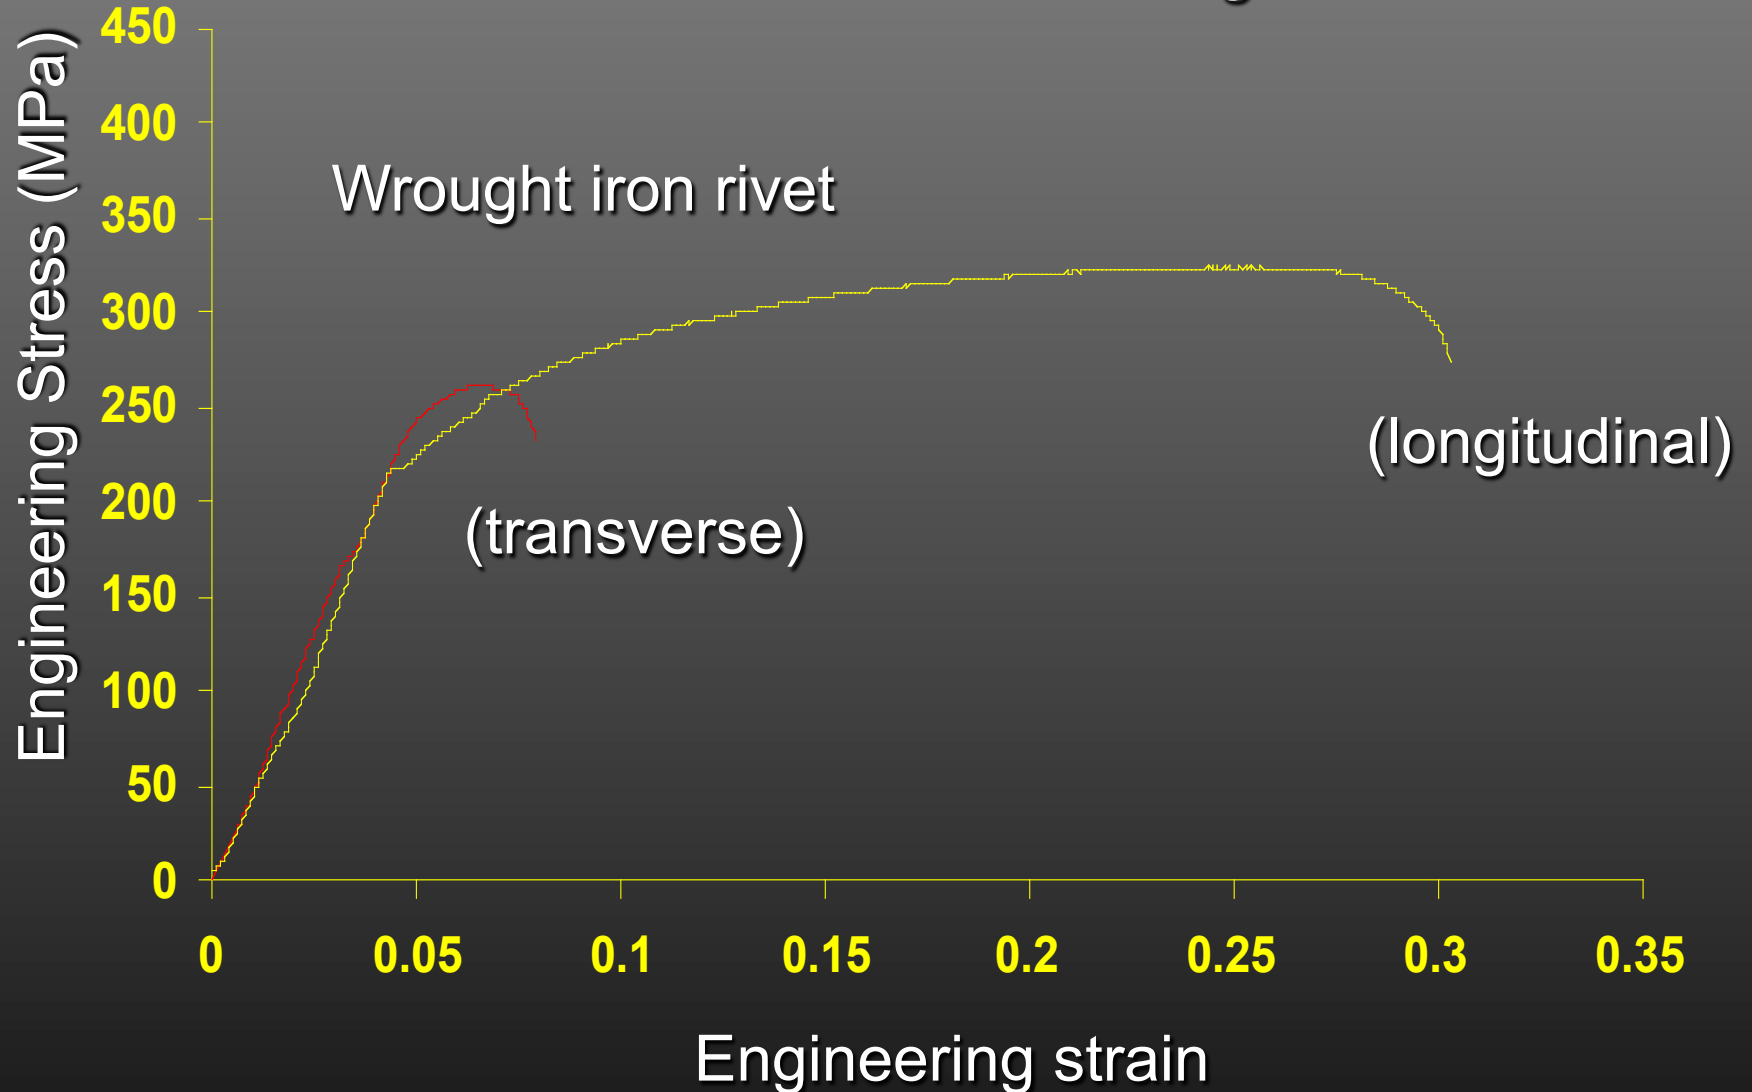
Uniaxial Tensile Testing

Variations among Titanic wrought iron, Titanic rivet steel and comparison material were studied as a function of:

- material
- orientation
- slag area percent
- slag aspect ratio

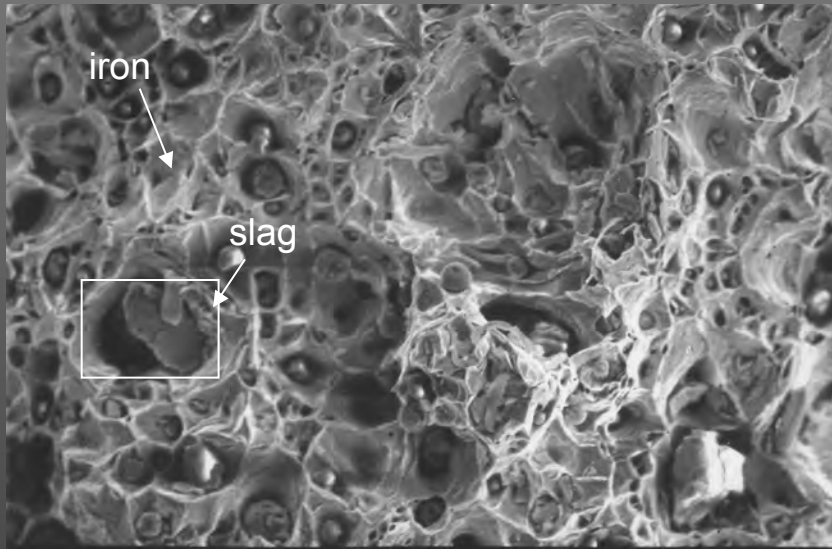
Longitudinal Orientation

Wrought Iron

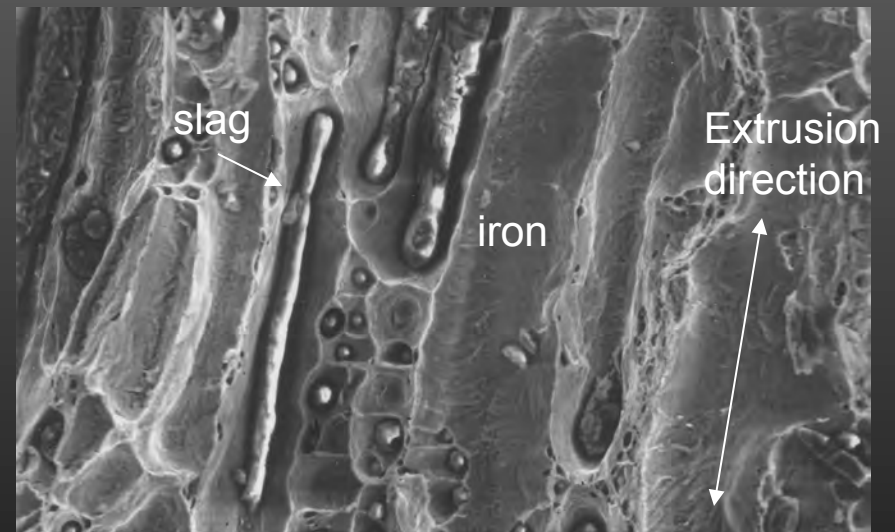
Transverse Orientation

Wrought Iron

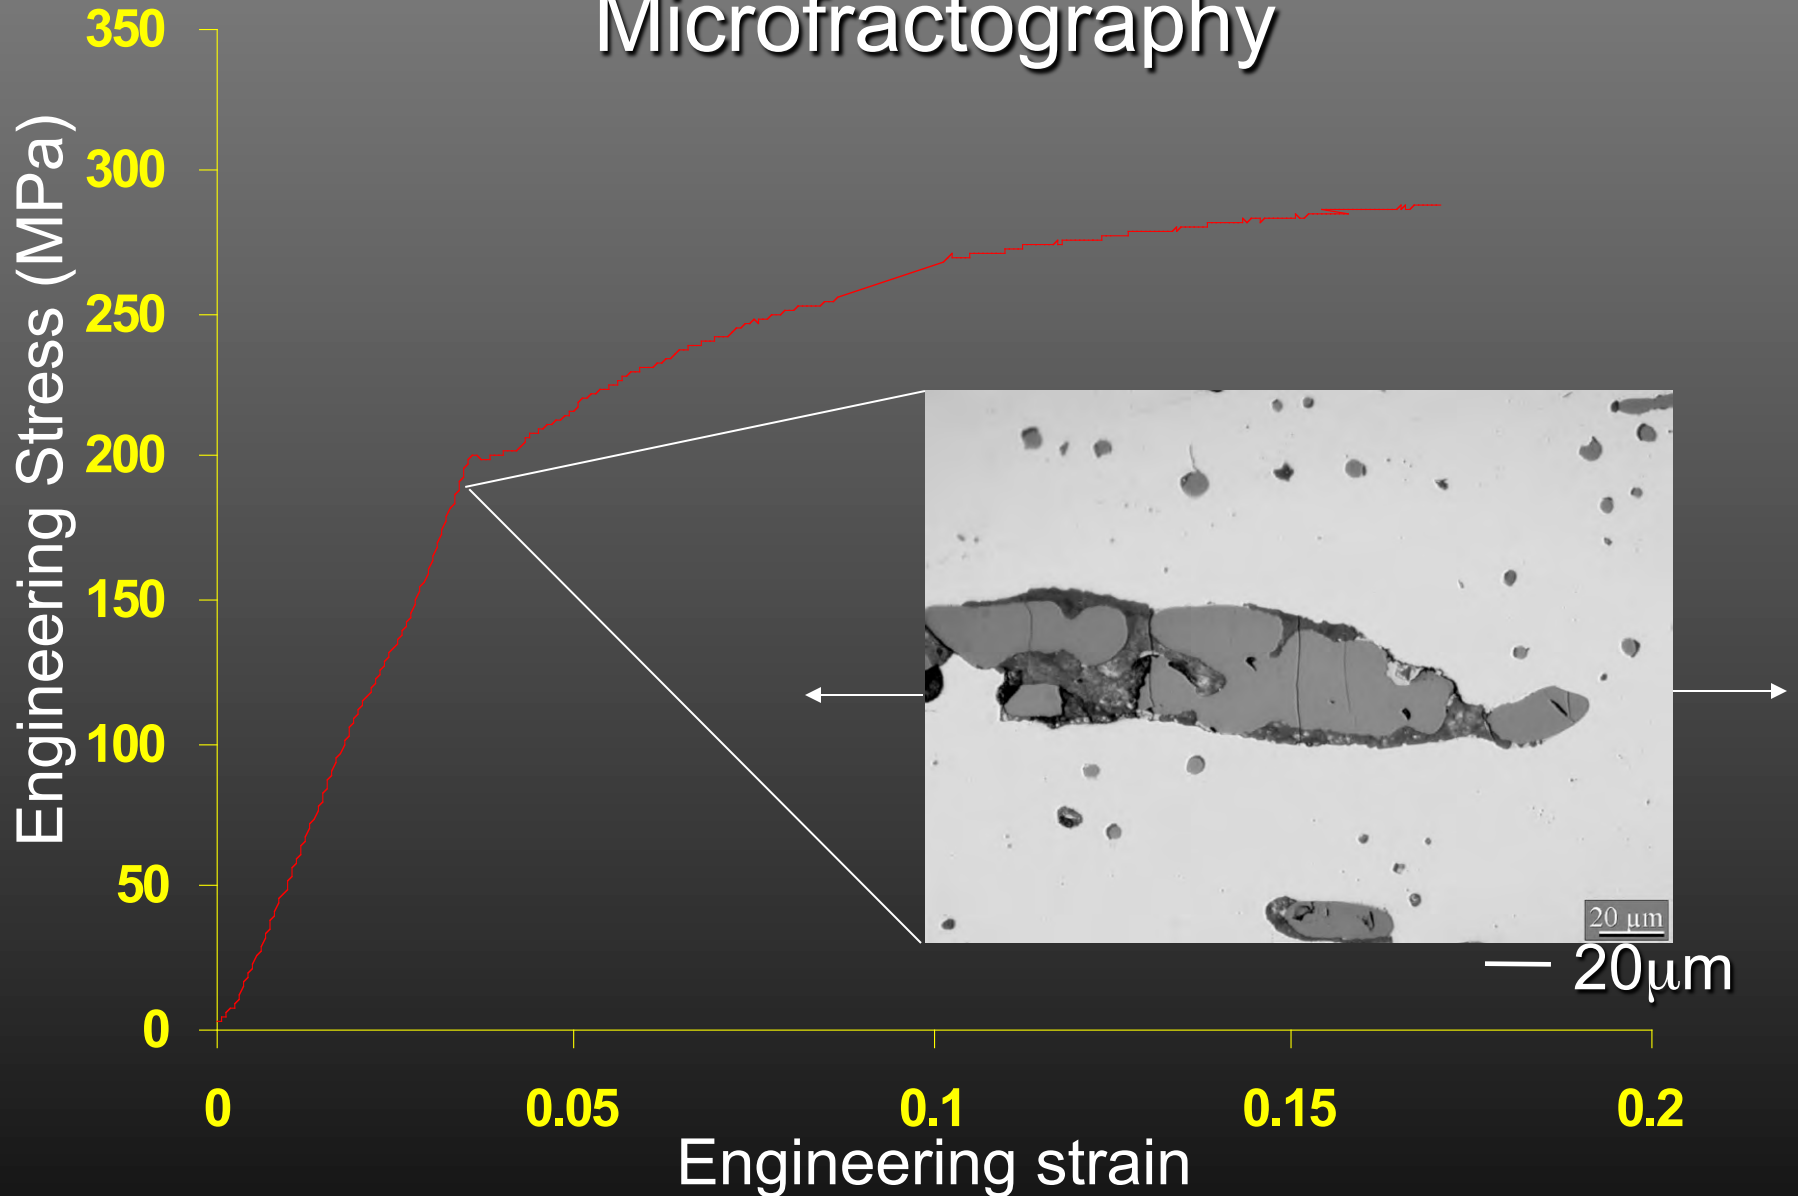
Fracture Strength of Slag

Microfractography
